MA 39 – VFA 2013-0044.01

Vienna, 21 June 2013

## Inspection Report

### Plastic Spacers (DL40/200 Rebar Spacers)

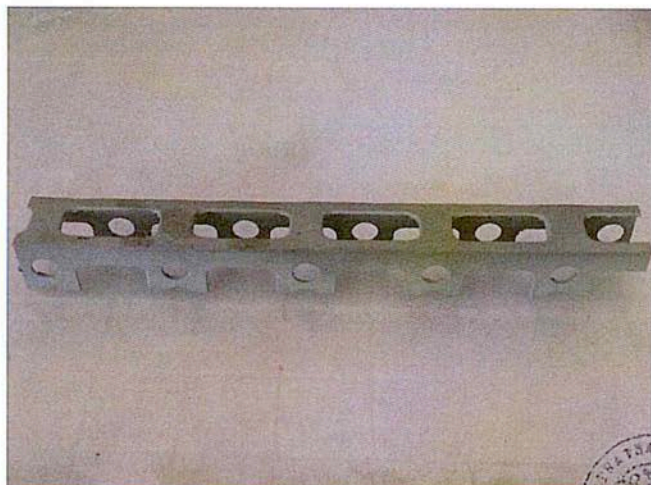
Photo No. 2013-0044-01-1

Plastic spacer (DL40/200  
Rebar Spacer)

Condition upon delivery

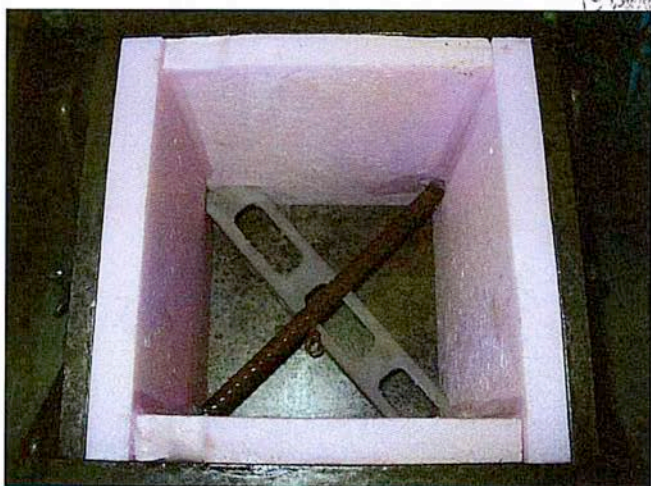
Photo No. 2013-0044-01-2

In deviation to the leaflet, polystyrene sheets were used in the cube moulds in place of plywood panels, and a reinforcement rod with a diameter of 8 mm with a spacer was placed inside (see Fig. No. 2013-0044-01-2).

Cube mould with  
reinforcement rod and spacer  
placed inside

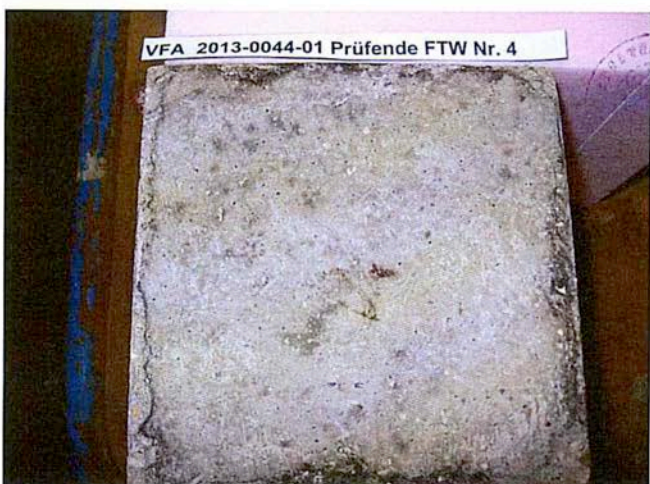
Photo No. 2013-0044-01-3

No cracking of any kind was determined, only a slight amount of flaking.

Freeze/thaw cycle testing

Sample 4 – after 56  
freeze/thaw cycles

Slight flaking of the surface  
can be determined, no  
cracking.

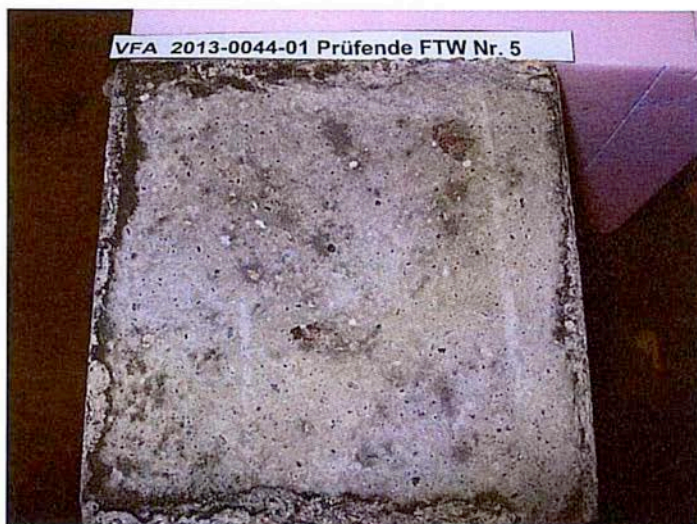
Photo No. 2013-0044-01-4

Freeze/thaw cycle testing

Sample 5 – after 56  
freeze/thaw cycles

Slight flaking of the surface  
can be determined, no  
cracking.

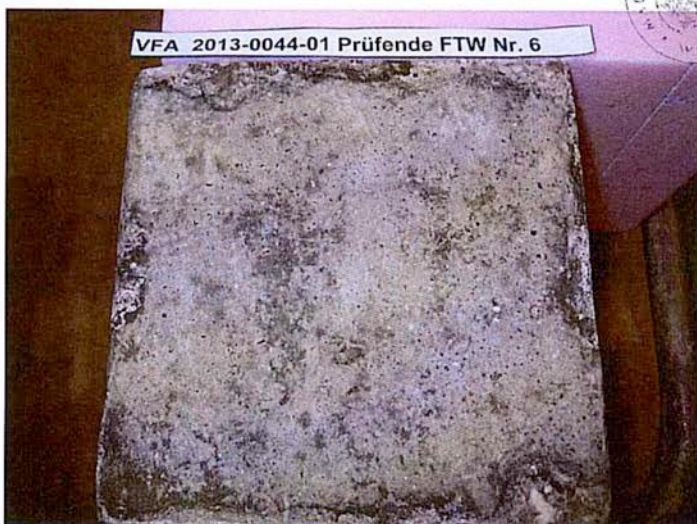
Photo No. 2013-0044-01-5

Freeze/thaw cycle testing

Sample 6 – after 56  
freeze/thaw cycles

Slight flaking of the surface  
can be determined, no  
cracking.

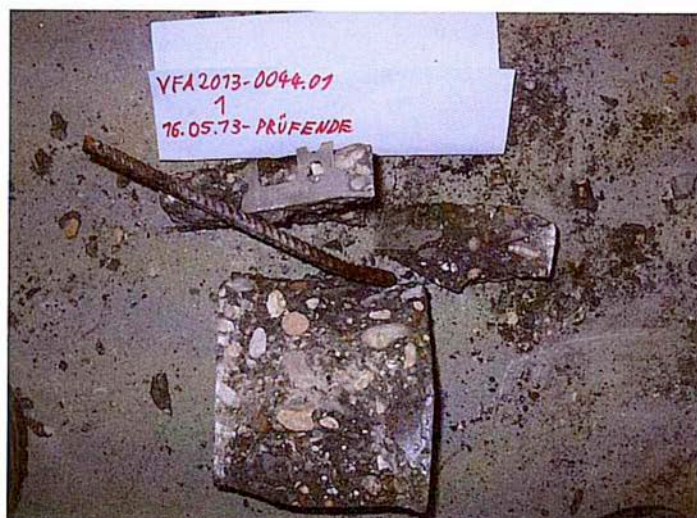
Photo No. 2013-0044-01-6

In samples 1 and 3, water penetration was visible up to the reinforcement bar.

Test of water penetration  
depth

Sample No. 1 –  
Water penetration depth: 40  
mm  
(up to the reinforcement bar)

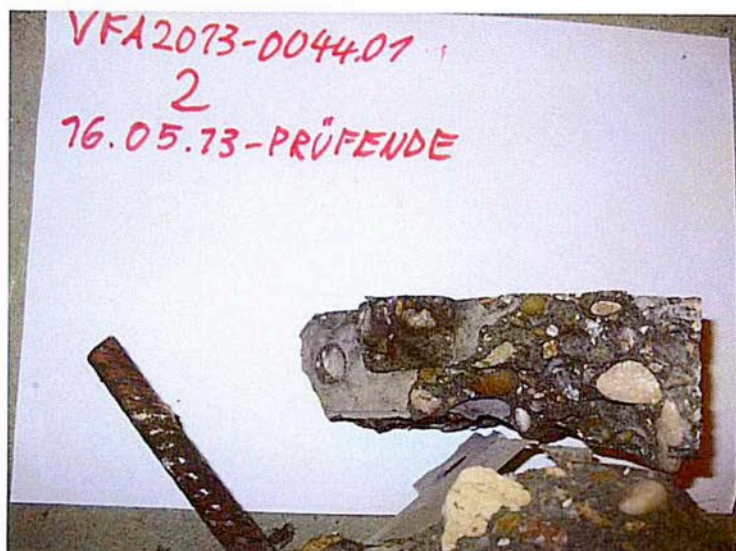
Photo No. 2013-0044-01-7

Test of water penetration  
depth

Sample No. 2 –  
Water penetration depth: 14  
mm

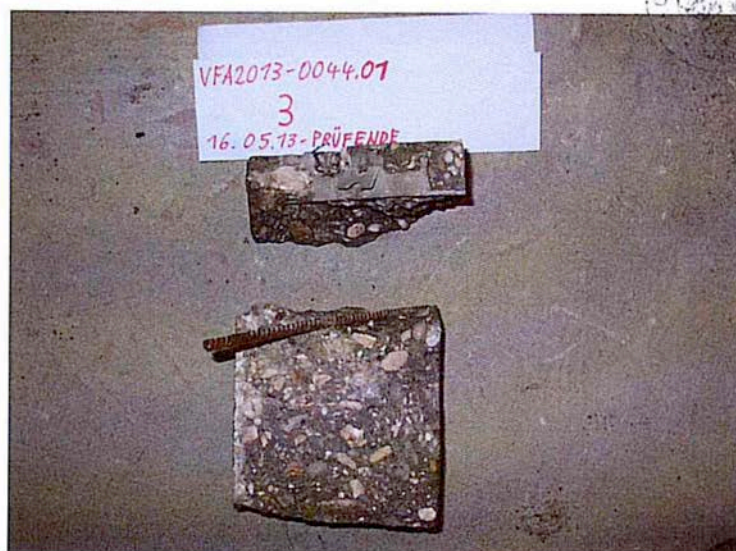
Photo No. 2013-0044-01-8

Test of water penetration  
depth

Sample No. 3 –  
Water penetration depth: 42  
mm  
(up to the reinforcement bar)
