MA 39 – VFA 2013-0044.01

Inspection Report

Plastic Spacers (DL40/200 Rebar Spacers)

Client: Nevoga GmbH

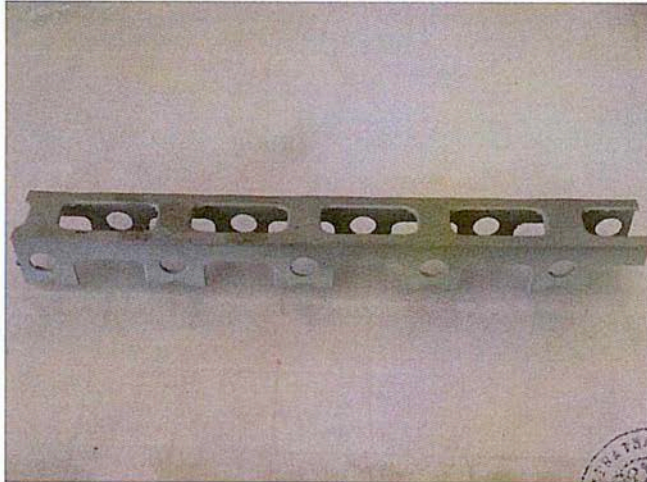
Photo No. 2013-0044-01-1

Plastic spacer (DL40/200
Rebar Spacer)

Condition upon delivery

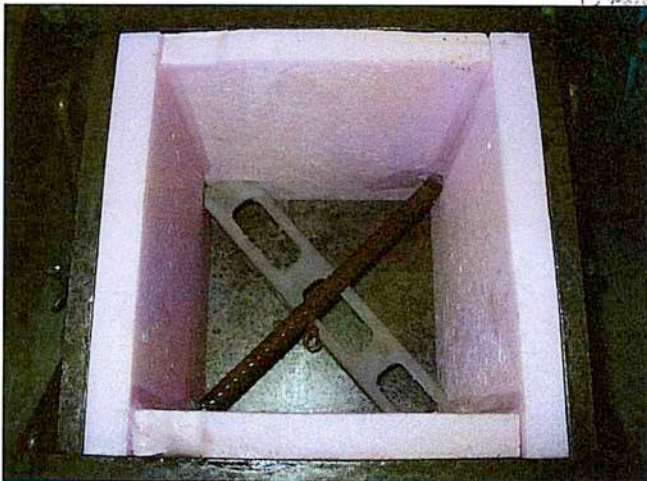
Photo No. 2013-0044-01-2

In deviation to the leaflet, polystyrene sheets were used in the cube moulds in place of plywood panels, and a reinforcement rod with a diameter of 8 mm with a spacer was placed inside (see Fig. No. 2013-0044-01-2).

Cube mould with
reinforcement rod and spacer
placed inside

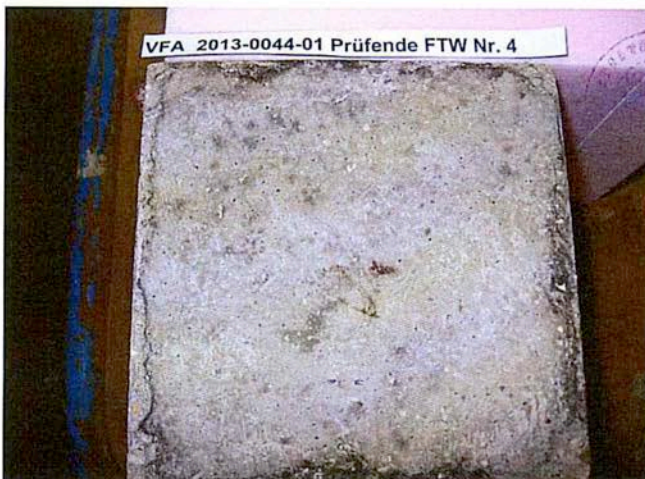
Photo No. 2013-0044-01-3

No cracking of any kind was determined, only a slight amount of flaking.

Freeze/thaw cycle testing

Sample 4 – after 56
freeze/thaw cycles

Slight flaking of the surface
can be determined, no
cracking.

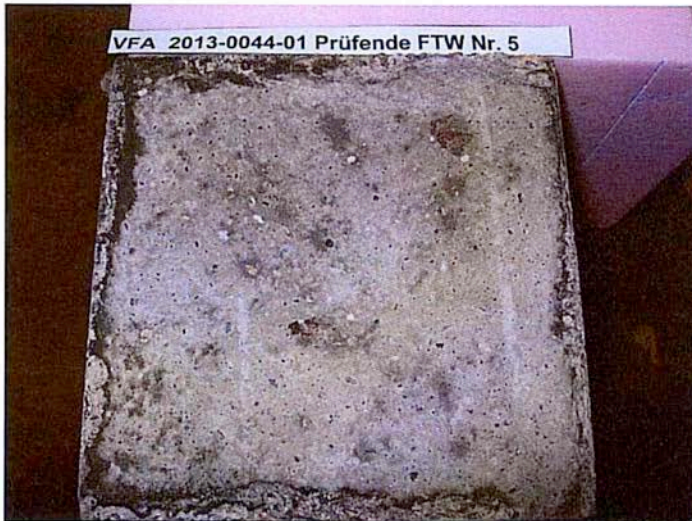
Photo No. 2013-0044-01-4

Freeze/thaw cycle testing

Sample 5 – after 56
freeze/thaw cycles

Slight flaking of the surface
can be determined, no
cracking.

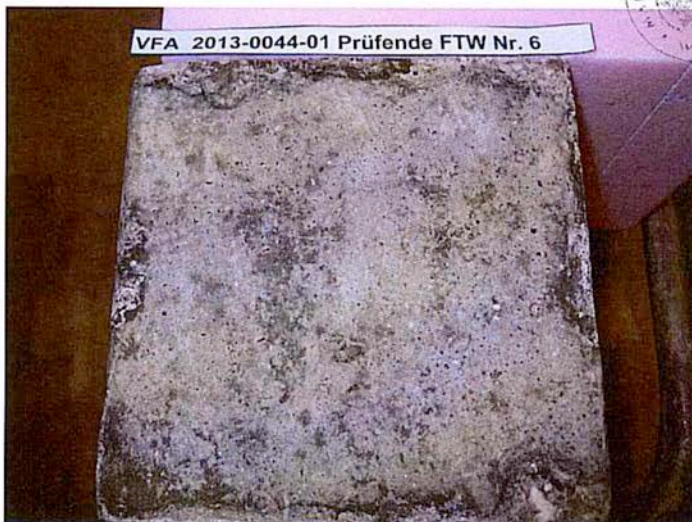
Photo No. 2013-0044-01-5

Freeze/thaw cycle testing

Sample 6 – after 56
freeze/thaw cycles

Slight flaking of the surface
can be determined, no
cracking.

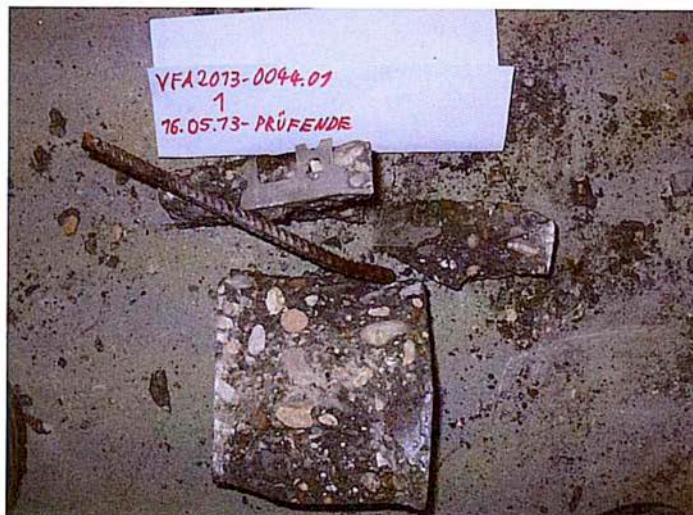
Photo No. 2013-0044-01-6

In samples 1 and 3, water penetration was visible up to the reinforcement bar.

Test of water penetration
depth

Sample No. 1 –
Water penetration depth: 40
mm
(up to the reinforcement bar)

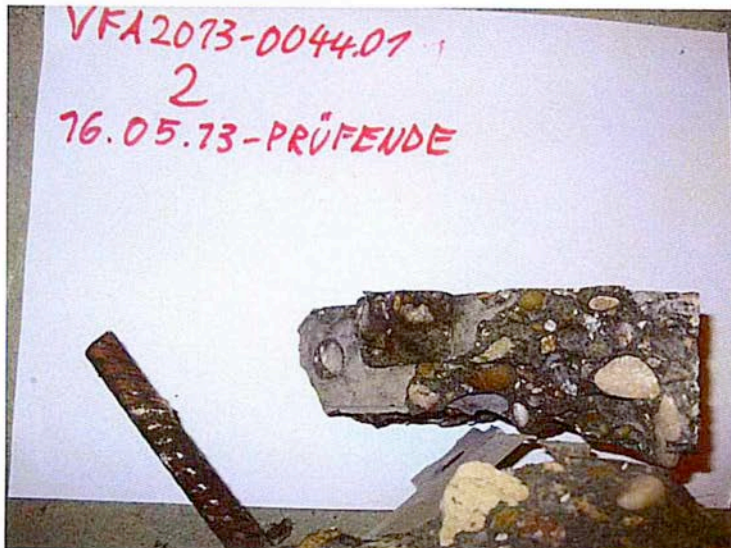
Photo No. 2013-0044-01-7

Test of water penetration depth

Sample No. 2 –
Water penetration depth: 14 mm

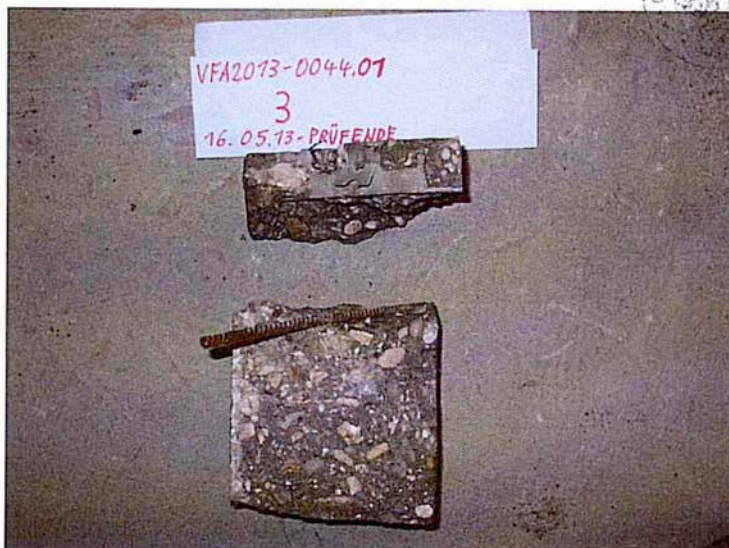
Photo No. 2013-0044-01-8

Test of water penetration depth

Sample No. 3 –
Water penetration depth: 42 mm
(up to the reinforcement bar)
