## Determination of radon transmission

SP was requested to measure the radon transmittance through a caulking compound material in accordance with SP Method no. 3873.

The client delivered the material, under the name of Sikaflex AT Connection, to SP Technical Research Institute of Sweden on 2015-02-20. There were no signs of visible damage to the material on arrival. The material was tested without joints on a gypsum board. See Appendix 2 for a picture of the material.

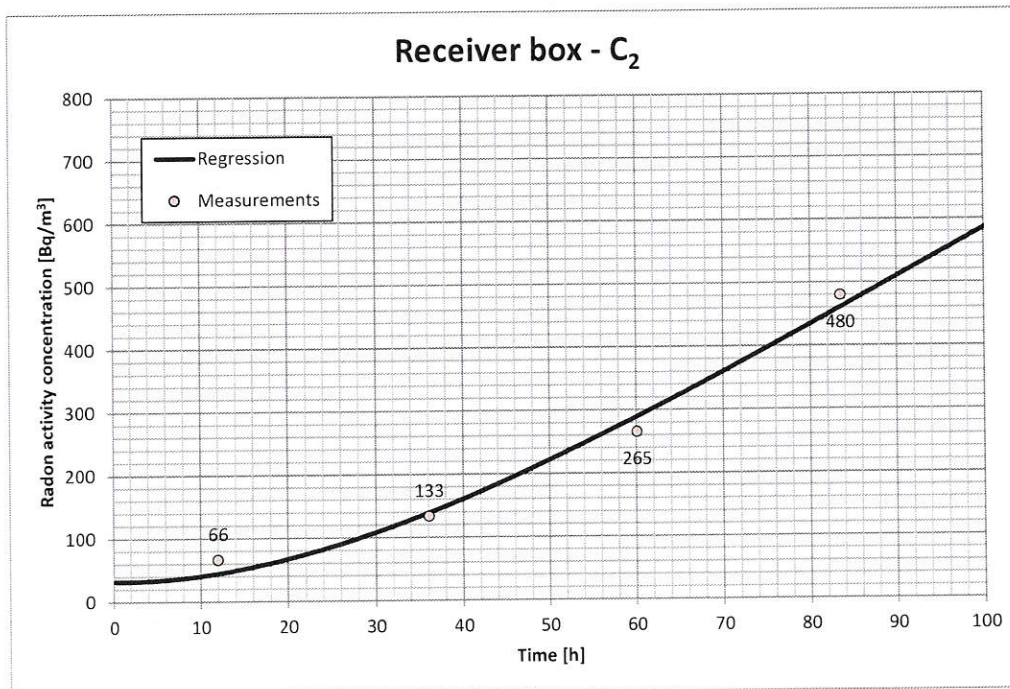
Figure 2 Radon concentration in the secondary box: measured daily average values and the regression curve.

by measuring the change in radon concentration on both sides of the test material. Figures 1 and 2 show how the radon concentrations build up in the two boxes.
